GPS Performance Degradation by Noise Generated by the U3

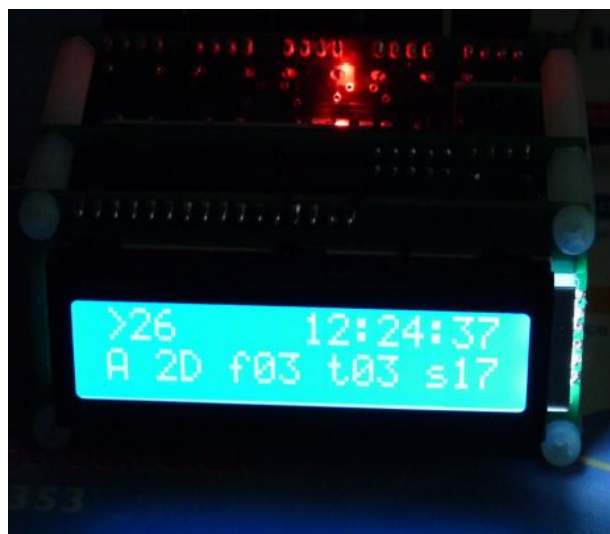
The Test U3 with 28MHz PI4 MGM transmission from the signal source U3. PI4 is a wide mode liable to produce sideband noise. Satellite numbers have dropped but is it due to TX noise.

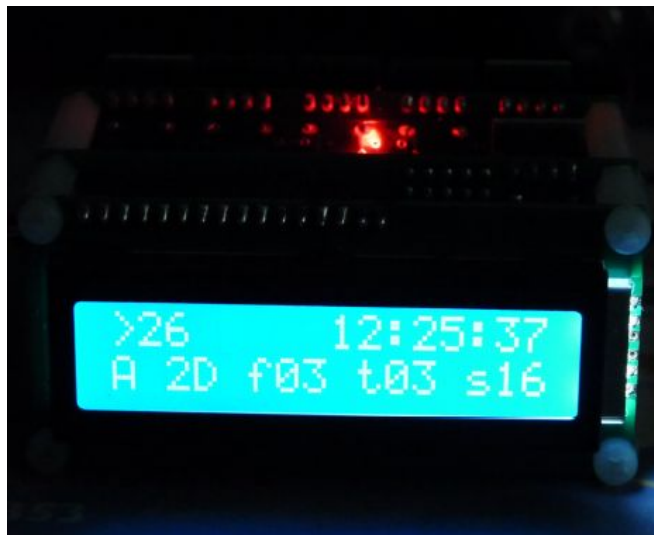
The Test U3 with 28MHz Carrier transmission from the signal source U3, the narrowest mode.

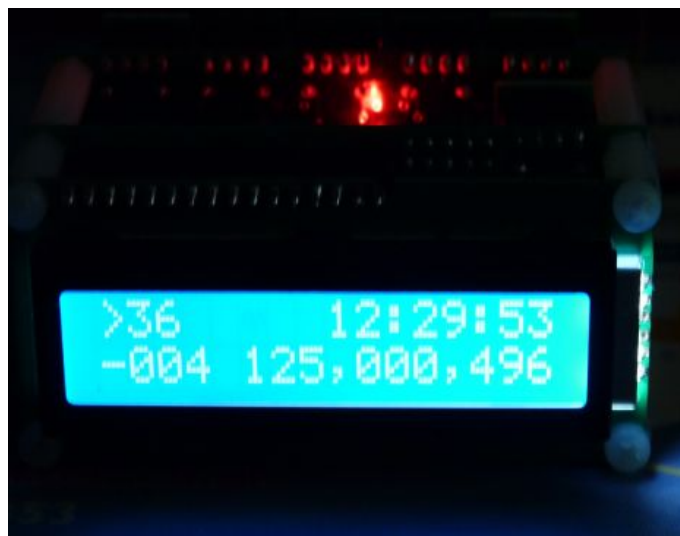
The Test U3 with 28MHz WSPR transmission from the signal source U3. The Test U3 has just completed a successful calibration during the WSPR.

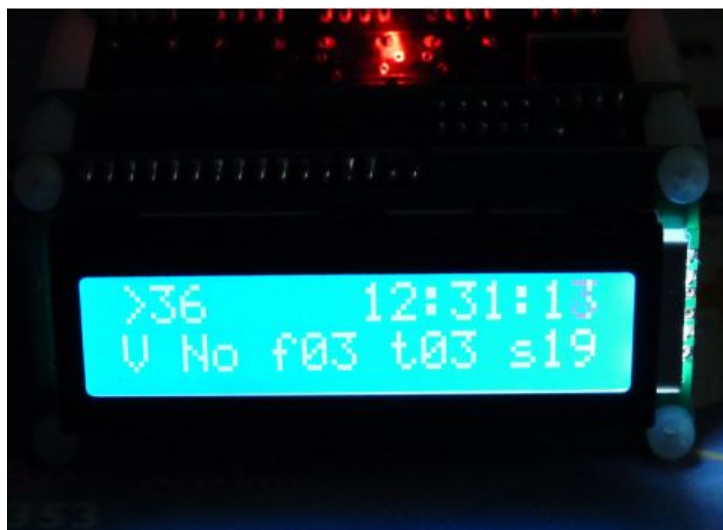
The Test U3 did a 10 second Calibration after the 28MHz WSPR transmission from the signal source U3. The 1PPS continued during the Calibration period and there was a 3D lock. This photograph is 1min 13sec after any source U3 activity, satellite signals have varied throughout the period and become marginal now. Further observation showed how poor a position the GPS was in and satellite number fell to fix 1 - track 1. I finally took pity on the Test U3 when it alternately flashed messages in Latin, Calo – Lato – Lngo followed by the complete display character set. And moved the GPS back to the window.
