GPS Performance Degradation by Noise Generated by the U3

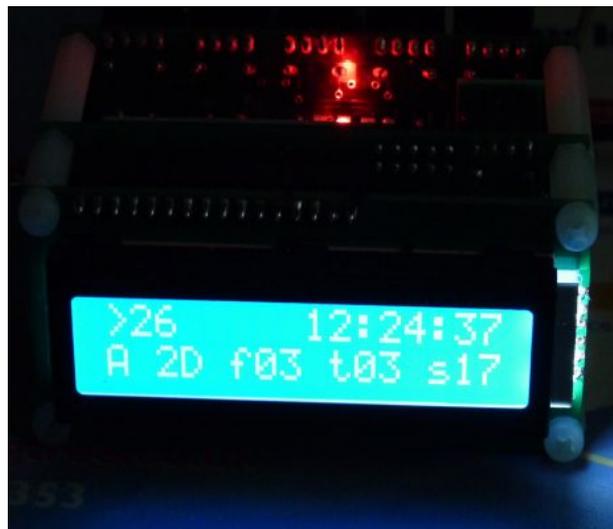
The Test U3 with 28MHz PI4 MGM transmission from the signal source U3. PI4 is a wide mode liable to produce sideband noise. Satellite numbers have dropped but is it due to TX noise.

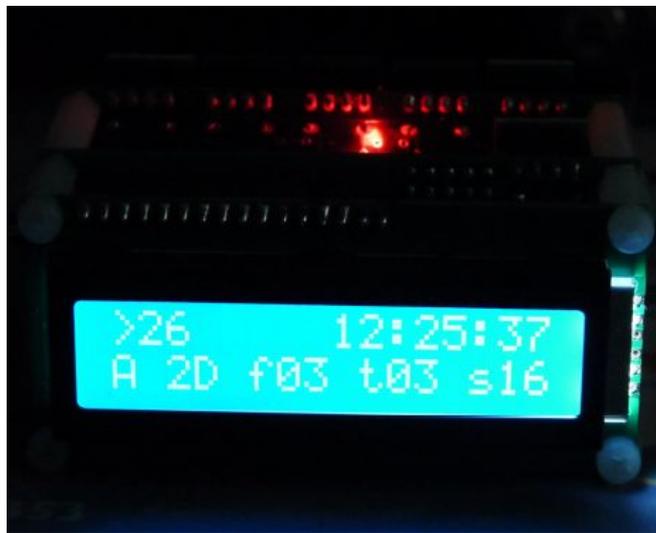
The Test U3 with 28MHz Carrier transmission from the signal source U3, the narrowest mode.
